King Saud University
Journal of King Saud University –
Science

GIS based landslide hazard evaluation and zonation – A case from Jeldu District, Central Ethiopia

Tilahun Hamza¹, Tarun Kumar Raghuvanshi*

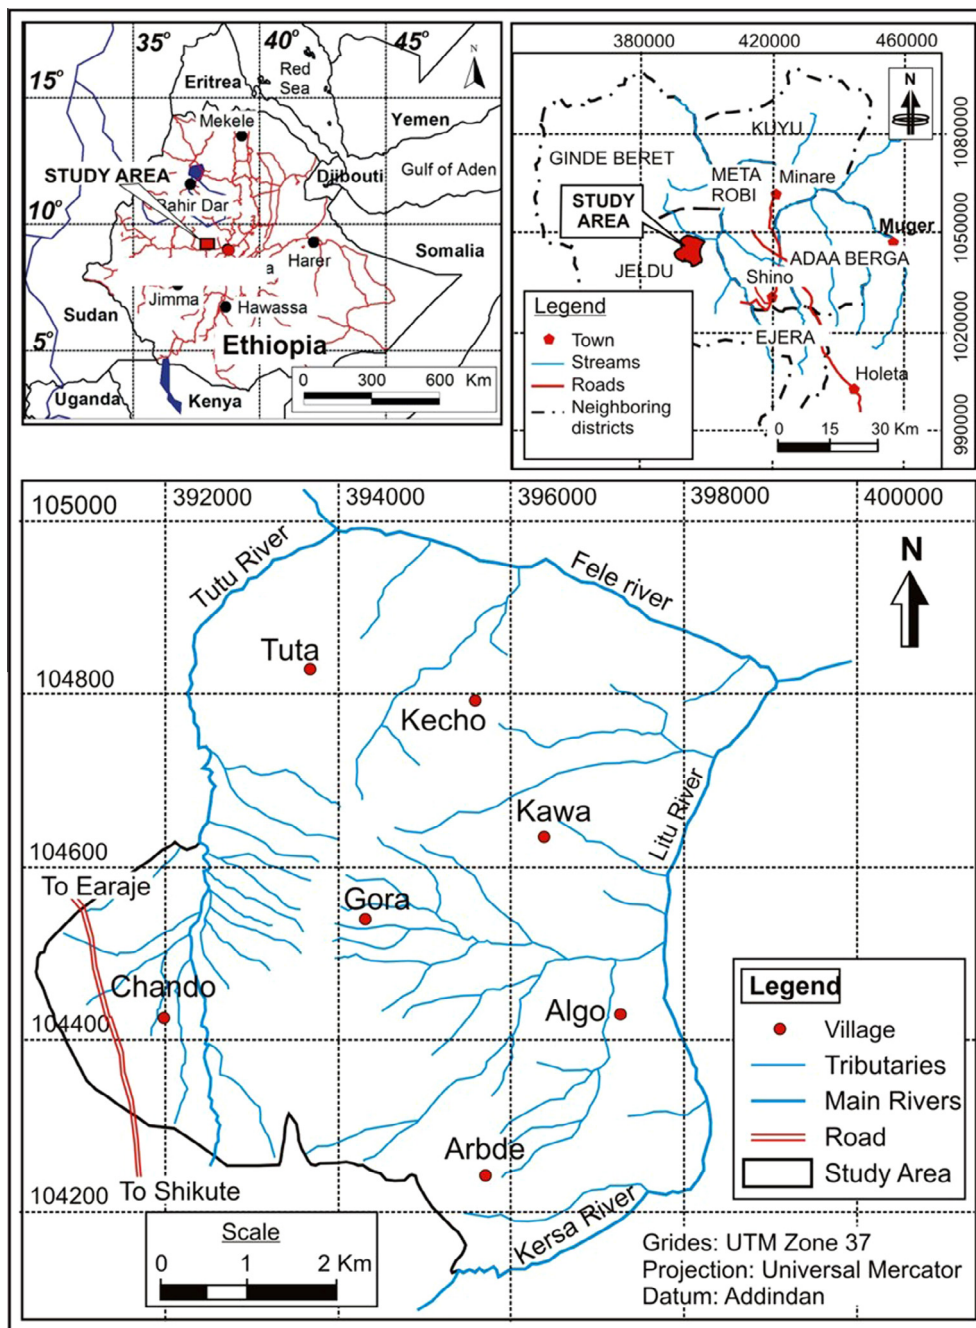
Figure 1 The study area.

West of Addis Ababa, the capital city of Ethiopia (Fig. 1). The area is characterized by rugged topography with altitudes ranging from 1497 m to 2426 m. The area has dendritic drainage with Tutu, Kersa, Fele and Litu Rivers, which are the tributaries of the Muger River. All these rivers ultimately join the Blue Nile (Abay) River. The study area falls in subtropical (1500–2300 m) to temperate (2300–3300 m) climatic zones (Daniel, 1977). The rainfall data collected from Kachisi Ethiopian Meteorological Agency station showed that the area gets 967 mm annual average precipitation (data for the period 2002–2011). The highest monthly average precipitation recorded in the area was 387.6 mm in August 2011. The area is characterized by uni-modal rainfall pattern with only one distinct rainy season (i.e. June to August).

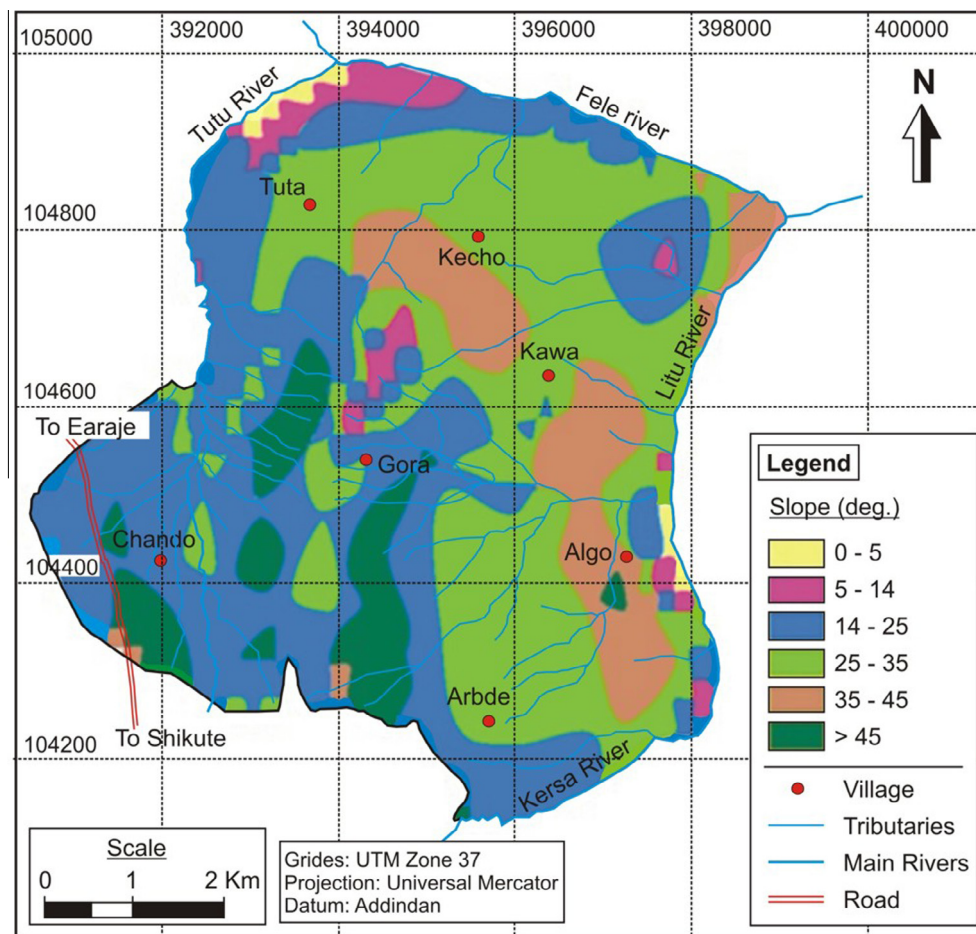
Figure 6 Slope map of the study area.

categories: (i) 0–5°, (ii) 5–14° (iii) 14–25°, (iv) 25–35°, (v) 35–45° and (vi) >45° as shown in Fig. 6. From the past landslides inventory data the distribution of landslides showed that 82% of the landslides occurred in the slope class 14–25° (Fig. 5). About 0.8% past landslides occurred in slope class 25–35° and 0.3% of the landslides occurred in the slope class 35–45° whereas, the remaining 5.2% of landslides were observed either in slope class less than 5° or above 45°. The reason for high concentration of landslides within slope class 14–25° is evident from the fact that most of these slopes are formed by either colluvium or by the alluvial soils. Also, much of the cultivated land falls within this slope class, as relatively gentler slopes favor agriculture practice. Further, it is a known fact that agricultural activities over slopes generally result into increase of soil moisture because of irrigation practice, thus it may induce instability in the slopes (Raghuvanshi et al., 2014). The slopes having angles greater than 45° represent mostly limestone in the present study area which is generally kinematically stable.

5.3.2.1.2. Slope. The hazard index value computation for slope factor revealed that the slope class 14–25° has maximum probability for landslide occurrence in the area, as it has demonstrated a very high value (47) of hazard index. This is followed by slope class 5–14° which has hazard index value of 6.67 (Table 2). Even slope class 0–5° also showed a probability of landslide occurrence as the hazard index value is 3. However, slope classes 25–35°, 35–45° and >45° showed low probability of landslide occurrence, as the hazard index values for all these classes are less than 1. In general, it was observed in the study area that the gentler slopes (slope inclination less than 25°) are generally formed by colluvium and alluvial material which by its general behavior is susceptible to failure. However, few landslides of different nature were also observed in steeper slopes comprising colluvium and alluvial material, overlying different bed rocks.

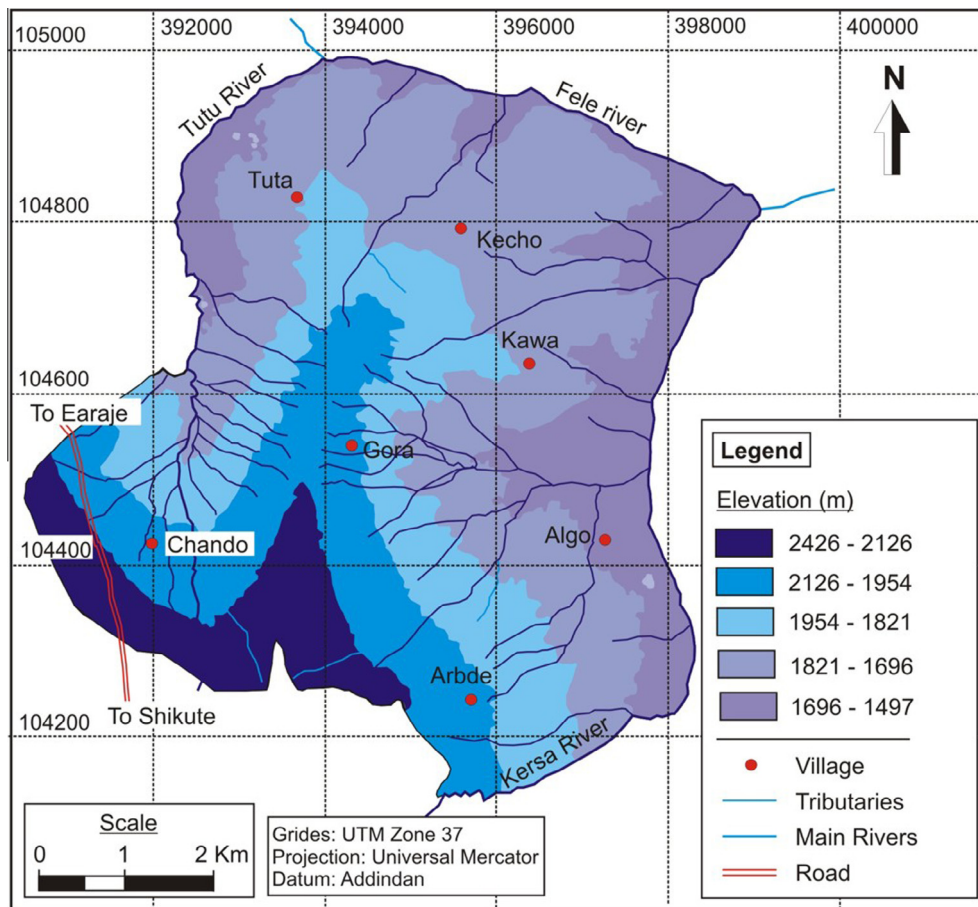
Figure 7 Elevation map of the study Area.

For the present study the elevation was sub divided into five classes: 1497–1696 m, 1696–1821 m, 1821–1954 m, 1954–2126 m and 2126–2426 m, respectively (Fig. 7). Data on past landslides in the area indicate that the highest distribution of landslides (68%) falls in the elevation class

1821–1954 m. This is followed by elevation classes 1497–1696 m (14%) and 1954–2126 m (11%). Further, the elevation classes 2126–2426 m and 1696–1821 m showed very less landslide distribution with only 5% and 2% of landslides, respectively (Fig. 5). The high distribution of landslides in elevation class 1821–1954 m may be mainly related to the presence of colluvium and alluvial material on these slopes.

5.3.2.1.3. Elevation. The maximum landslide hazard in the study area was recognized in elevation class 1821–1954 m, as the hazard index value for this elevation class was computed to be 4.7. Also, elevation class 1497–1696 m showed a moderate probability of landslide occurrence with hazard index value

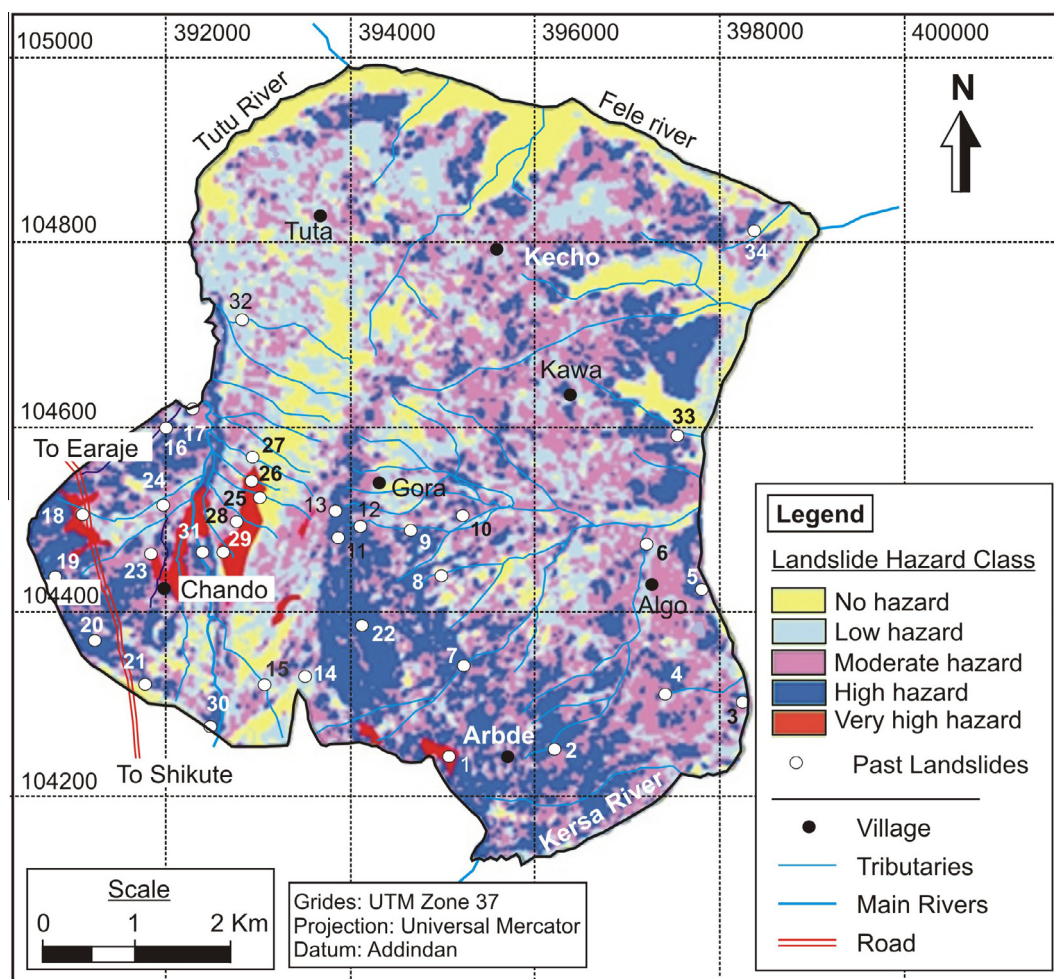
Figure 10 Landslide hazard zonation map.

The landslide hazard map prepared for the present study area (Fig. 10), has revealed that 12% (5.64 km²) of the study area falls under no hazard, 27% (12.69 km²) as low hazard, 32% (15.04 km²) as moderate hazard, 21% (9.87 km²) as high hazard and the rest 8% (3.76 km²) as very high hazard. Further, perusal of Fig. 10 clearly indicates that very high hazard (VHH) zones are mainly concentrated in the southwestern regions of the study area. Similarly, high hazard (HH) zones are mainly distributed in southern and southwestern region with scattered distribution in eastern and northern regions in the study area. The moderate hazard (MH) zones have scattered distribution toward eastern and northern regions of the study area. Low hazard (LH) zones are more concentrated toward the northwestern region and scattered distribution in central and eastern regions of the study area. No hazard (NH) zones are mainly concentrated in the northern region

suitable hazard zonation in the present study area various distributions of Hazard (x) values were made. For each such attempt overlay analysis with past landslide data was attempted. The classification of Hazard (x) values presented in Table 4 provided the most reliable validation results with the past landslide data in the present study area. Fig. 10 presents the landslide hazard zonation map of the study area.

An attempt was made to validate LHZ map prepared during the present study, for which overlay analysis was performed with the help of past landslide data. The overlay analysis revealed (Fig. 10) that 82% of the past landslides fall in the high hazard zone and 10% in very high hazard zone. Thus, 92% of the past landslide locations showed satisfactory agreement with the prepared LHZ map. The remaining 2% landslides fall in low hazard and 6% in moderate hazard zones.

modes were recognized in limestone, colluviums and alluvial soils, respectively. Most of the landslides were surficial and involved alluvial and colluvium material of limestone origin. Also, some old landslides showed manifestation of reactivation, especially immediately below the cliff forming limestone in the area. Further, during the field survey it was observed that debris flow and translational mode of failures are the two predominant modes of failure which are mainly concentrated in the northern and southwestern regions of the study area. This fact was further validated with the hazard zonation as VHH and HH zones are concentrated toward the southwestern region of the study area.
